# FIELD HOME

YORKTOWN, NEW YORK

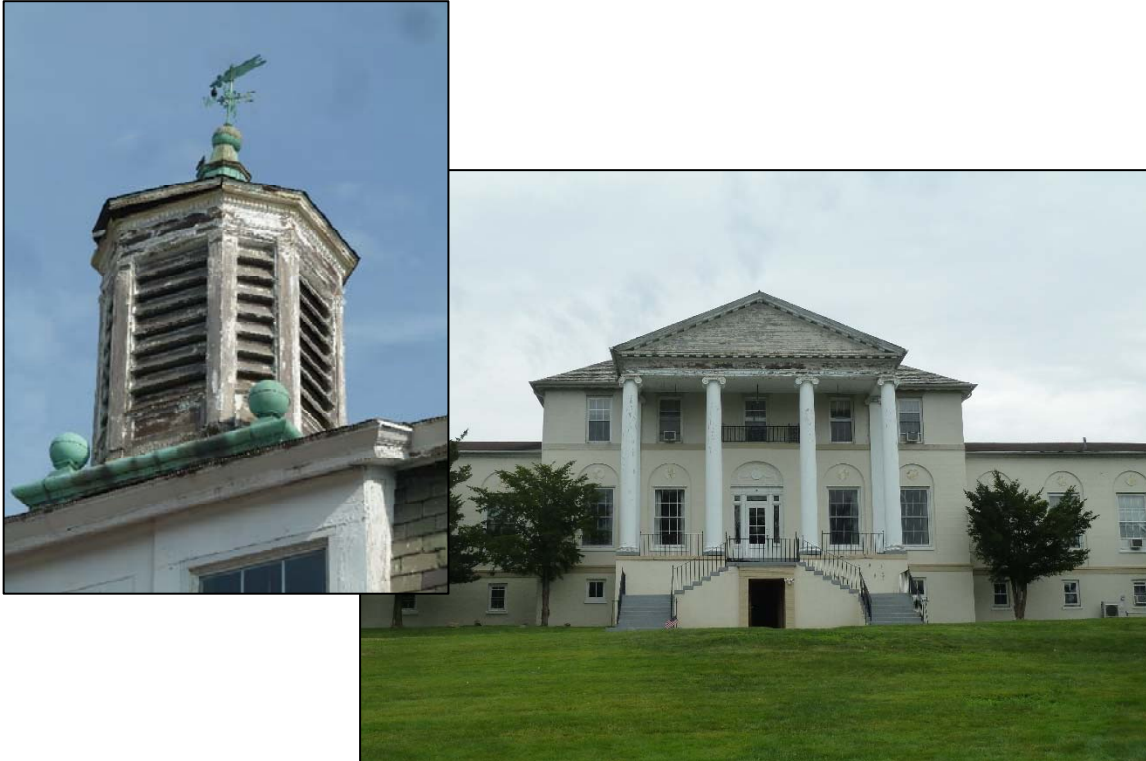
## REPORTS: HISTORIC ANALYSIS, CONDITIONS & ADAPTIVE REUSE

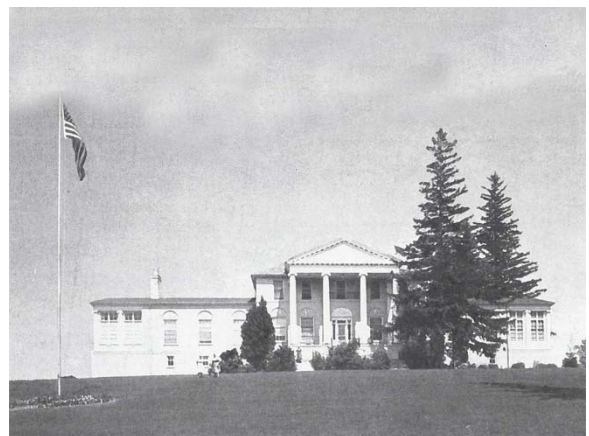
1980s, West Elevation (1924 addition)  
Image: L. G. Cooper et al, *Postcard History Series - Yorktown*

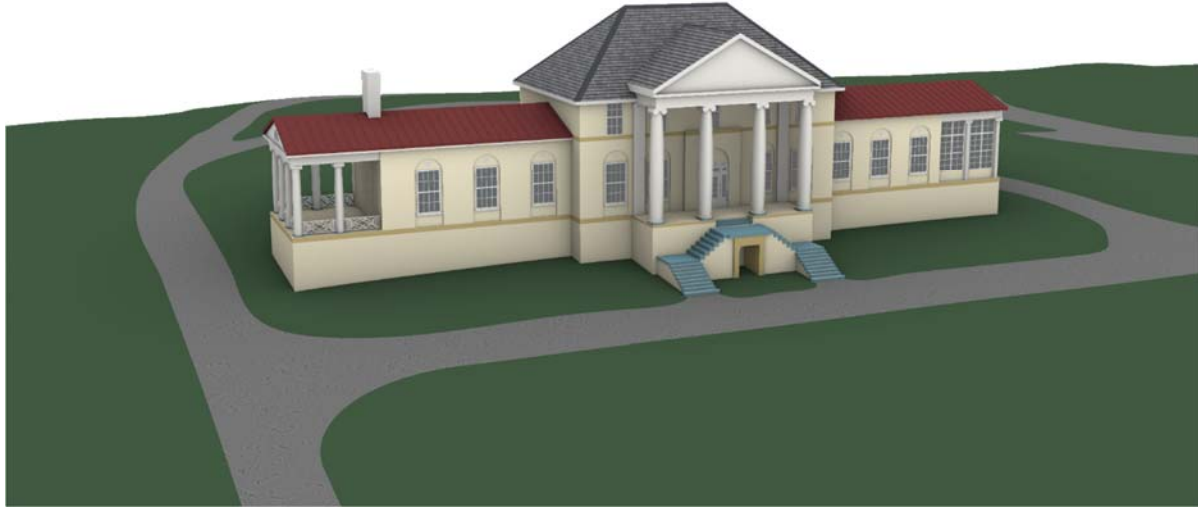
### “Work Here” Office Option

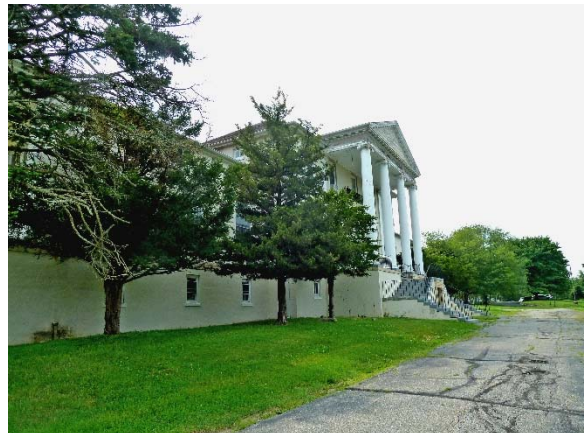
Driveway along formal entry at 1924 Addition, looking southward

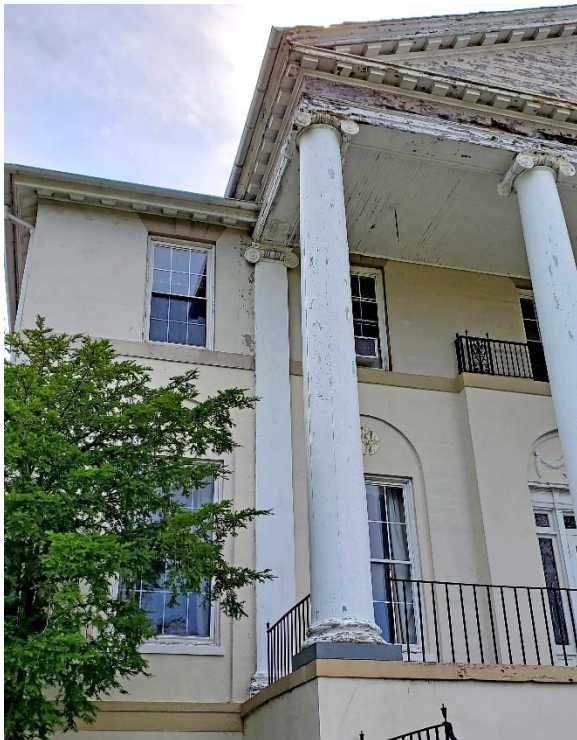
Details of portico: flaking paint on wood pediment, columns, & concrete wall; severely deteriorated volutes on Ionic capitals

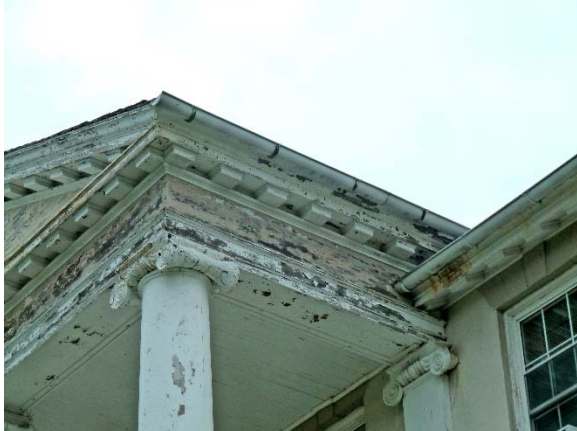
Details of portico: flaking paint at entire wood pediment, entablature & columns; staining below main façade gutter

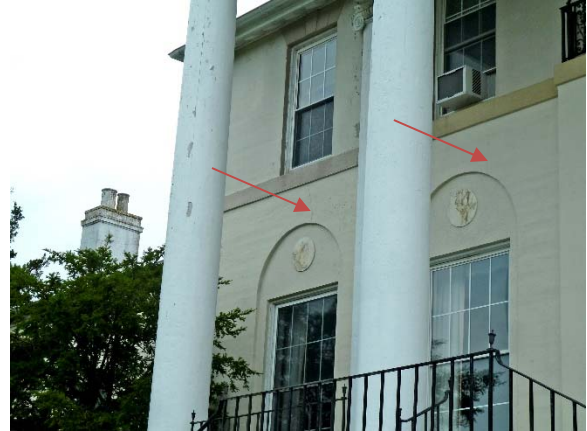
Vertical cracks in concrete wall between first & second floor window openings (all bays of portico)

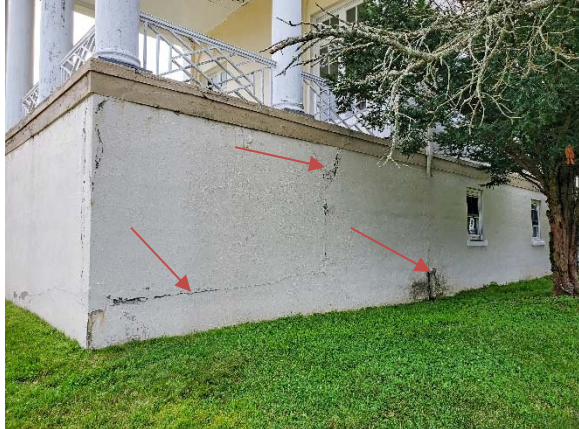
West Pavilion: vertical & horizontal cracks in basement wall & at porch floor/table; missing portion of downspout (right)

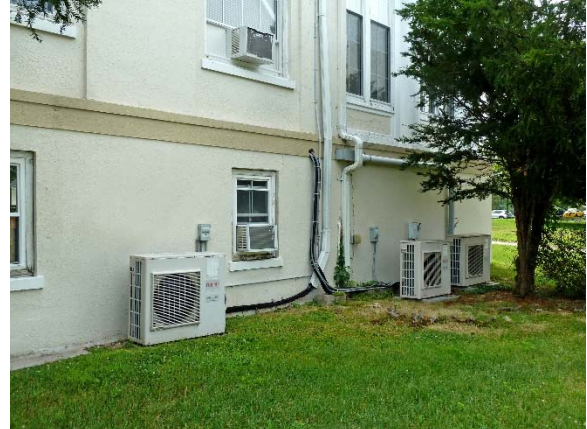
In-window air conditioning units; multiple split system condensing units with conduit overlapped by downspout

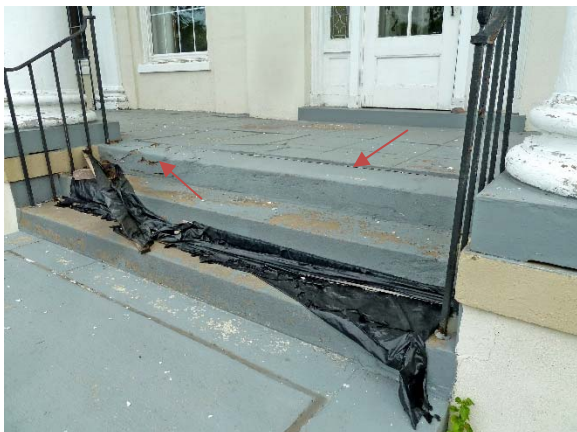
Portico floor: deteriorated/spalling concrete stair edge, uneven pavers, peeling paint (floor & ceiling above)

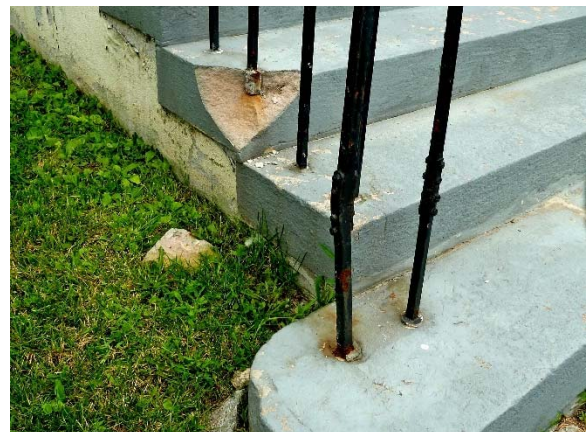
Staircase at entry: corner of concrete step popped off; visibly repaired, rusty iron balusters; peeling paint on concrete wall

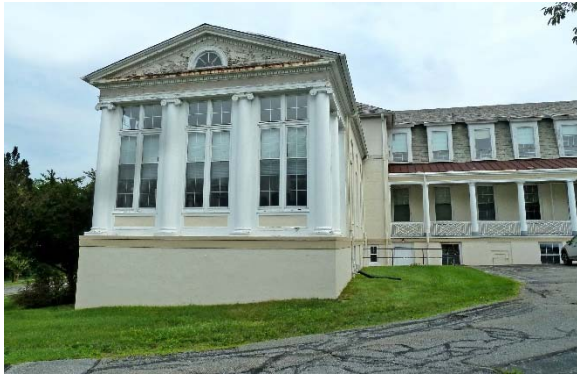
South Pavilion (enclosed), 1924 addition: peeling paint & rusting at pediment & engaged Ionic columns

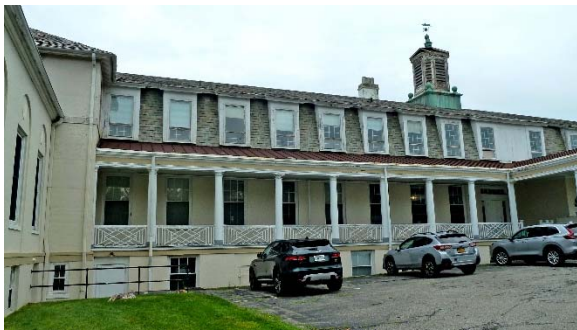
Central Addition (1897): porch in fair condition with likely original standing seam roof, replacement balusters, parking

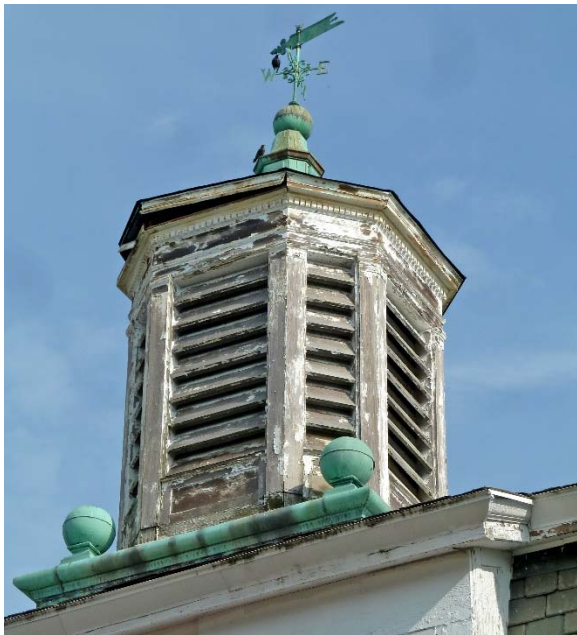
View of existing louvered cupola from southeast: portion of roof lifting upward; little paint remains; copper details; birds

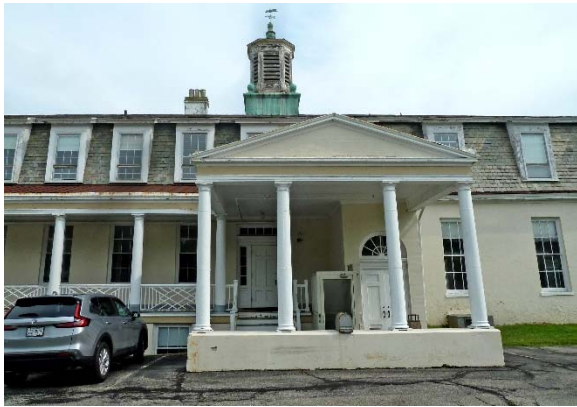
Entry portico (1924 Addition): stair to entry doors on porch; lift to porch/first floor level; vestibule leading to Chapel

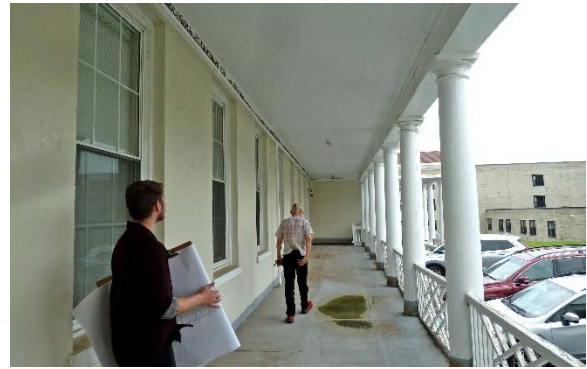
South porch: replacement balusters, coated floor and Tuscan column bottoms; bird deterrent visible above windows

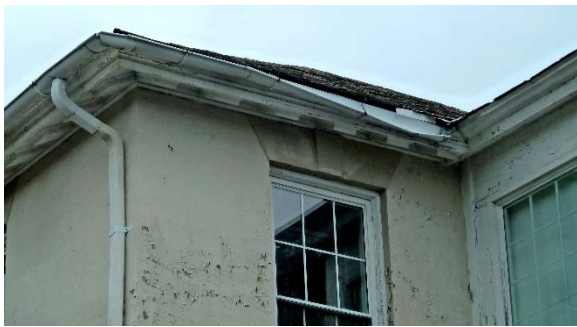
East wall of 1924 Addition: deformed gutter allowing stormwater overflow down wall; peeling paint

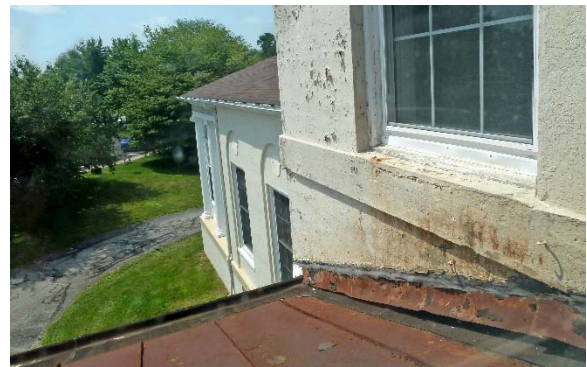
East wall of 1924 Addition: peeling paint and visible staining on concrete walls; original porch roof and flashing with repairs

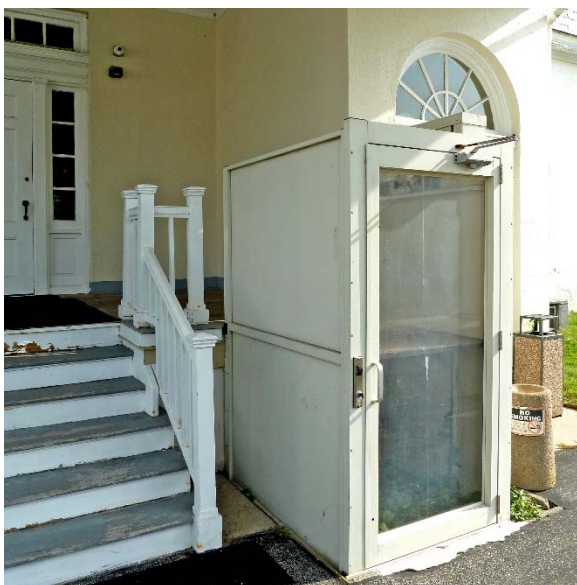
Stairs and lift (possibly inoperable) beneath entry portico, providing access to porch/first floor level

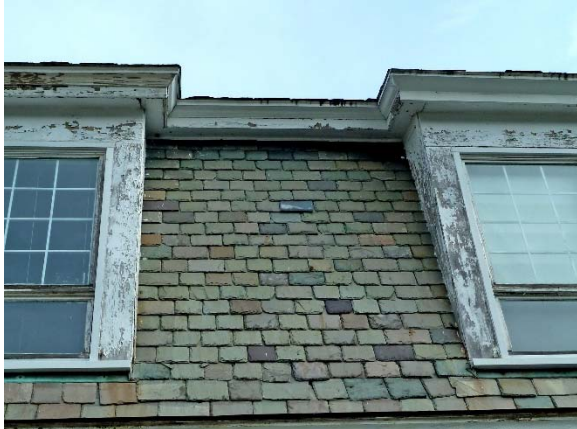
Chapel, south elevation: Slate gambrel roof in fair condition with some slates slipping or displaced; peeling dormer trim

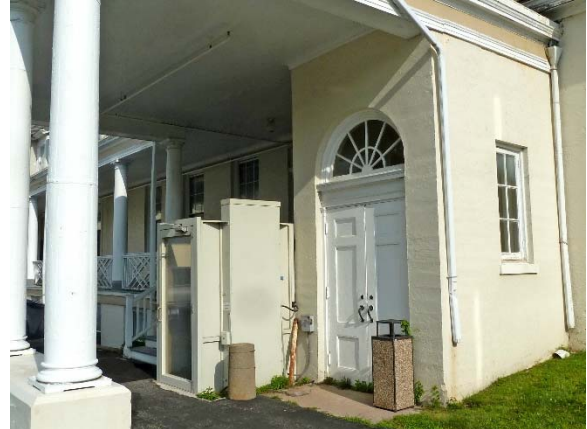
Entry portico (1924 Addition): lift to porch/first floor level adjacent to vestibule leading to Chapel (all beneath roof)

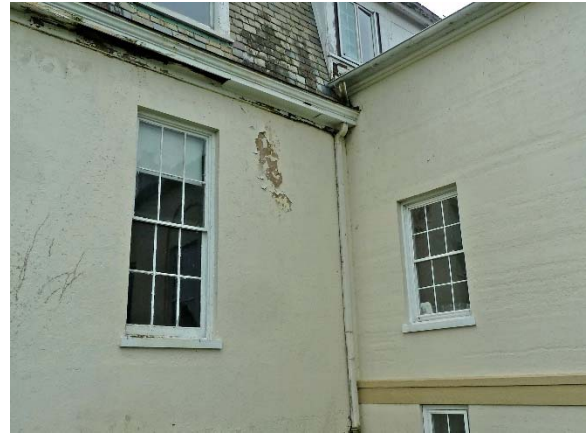
Chapel, north elevation: roof soffit very deteriorated and open; peeling paint on wall; downspout at corner with pavilion

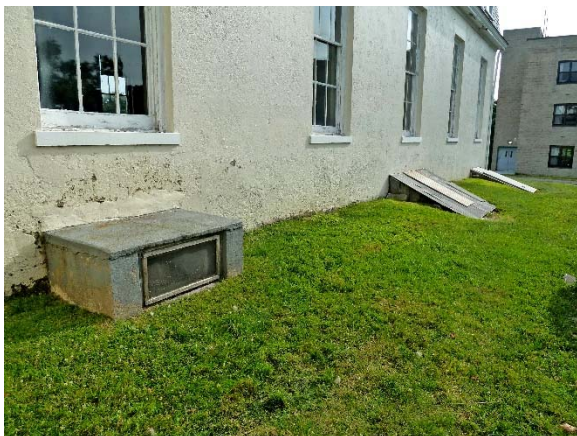
Chapel, south elevation: peeling paint and repairs at lower walls; access point to basement level

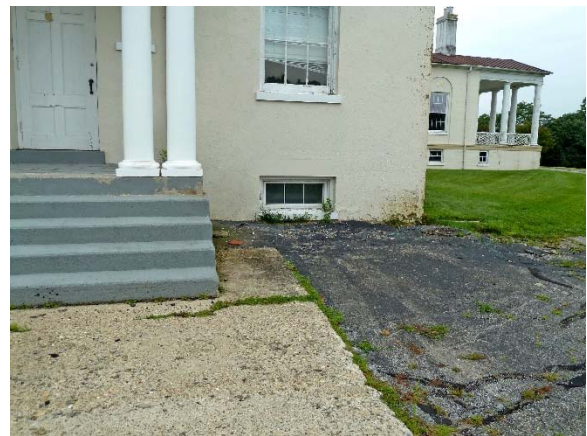
Chapel, east elevation: peeling paint along northeast corner of building & concrete stair; macadam driveway with repairs

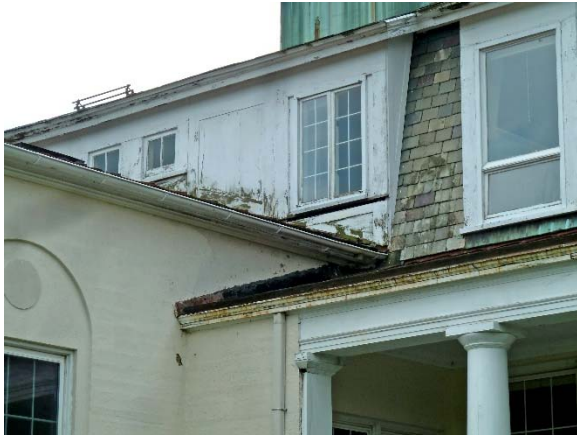
Dormer above East Pavilion: wood panels adjacent to roof very deteriorated from splash back; disconnected triangular panel

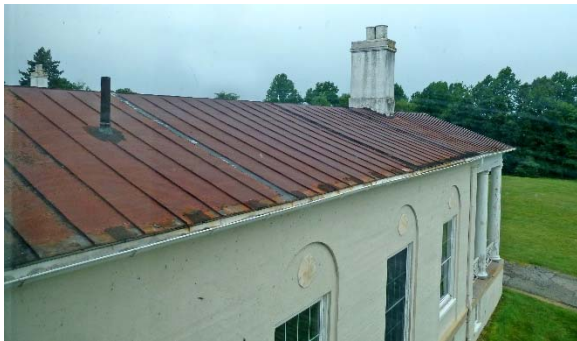
East Pavilion roof (likely original standing seam, 1924); at end of service life with numerous repairs/rust; gutter drooping

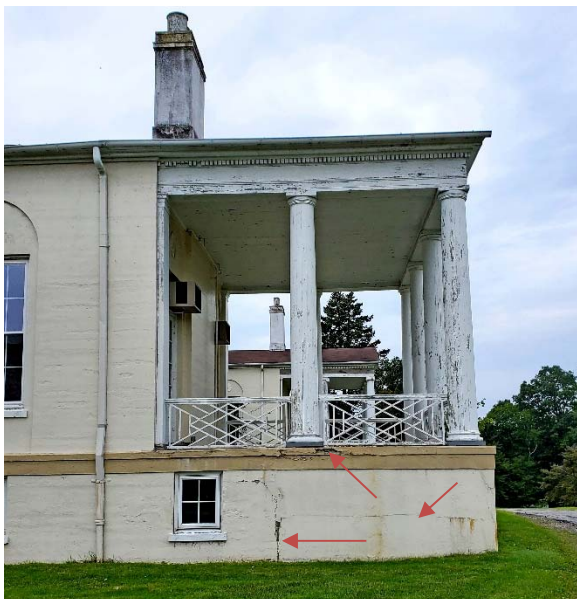
East façade of East Pavilion: horizontal & vertical cracks at basement level; broken edge of porch floor; Tuscan columns

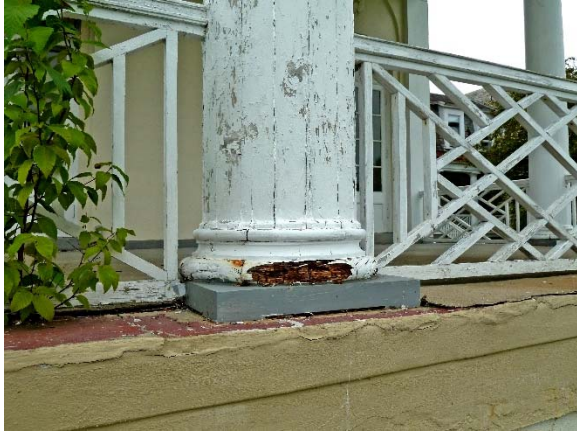
East Pavilion: extremely deteriorated torus of column along north façade; porch floor covering peeling away

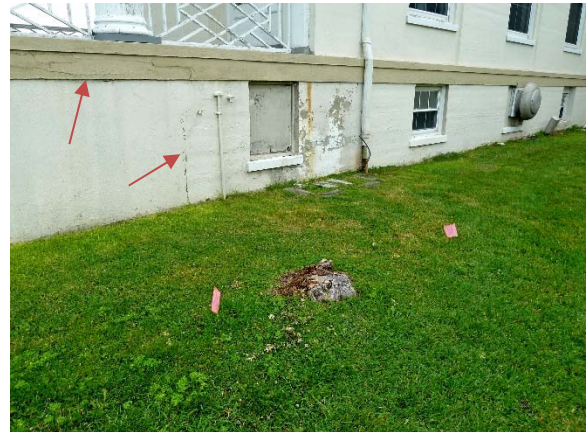
East Pavilion, west wall: cracks at basement level where interior spaces begin & at water table/edge; peeling paint

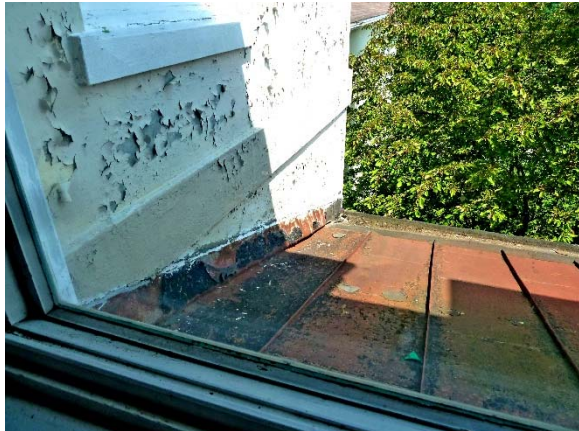
East wall of 1924 Addition: peeling paint and visible staining on concrete walls; original Porch roof and flashing with repairs

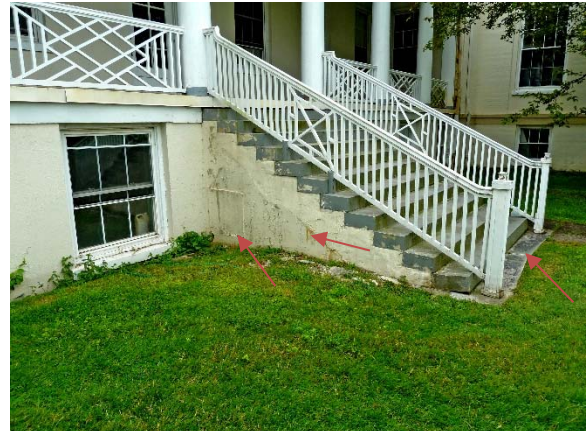
North porch stairs: visible structural cracks on side wall(s); displaced & rotated lowest two stairs/treads; peeling paint

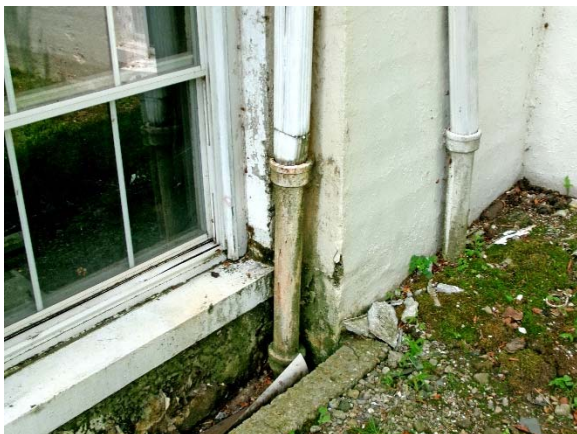
Drainage trench outside basement windows at western end of façade; significant mildew/moss; water infiltration to interior

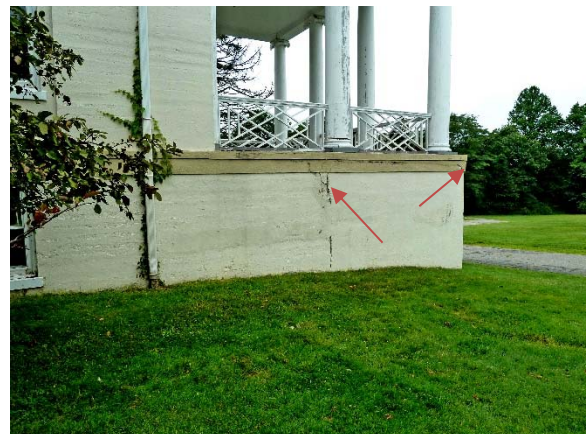
East façade of West Pavilion: vertical cracks at basement level; broken edge of porch floor; Ionic column separating

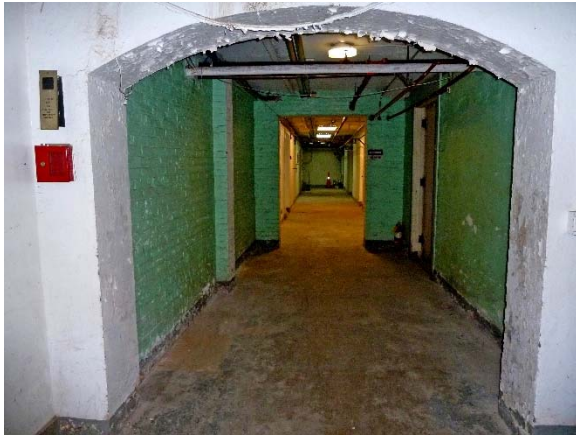
Central hallway inside exterior entry, looking eastward to Chapel basement/mechanical room

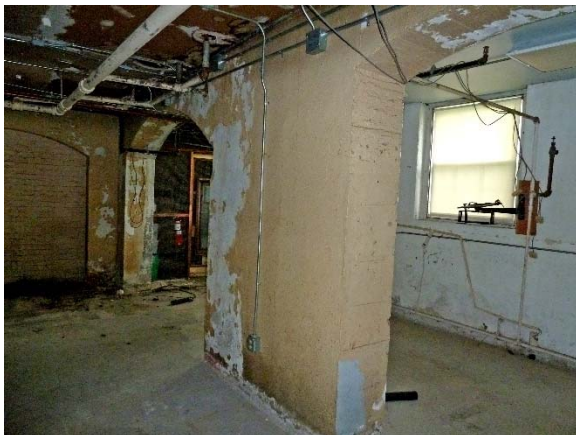
Structural arches outside elevator mechanical space (south rooms); peeling paint; deteriorated & stained ceiling boards

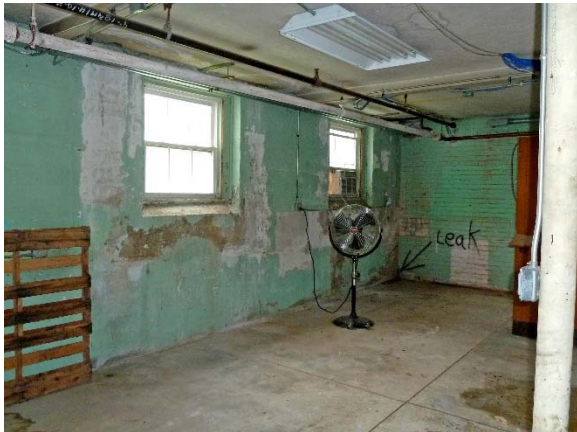
East wall of basement below South Pavilion: deteriorated wall finish; peeling paint, leak kindly identified

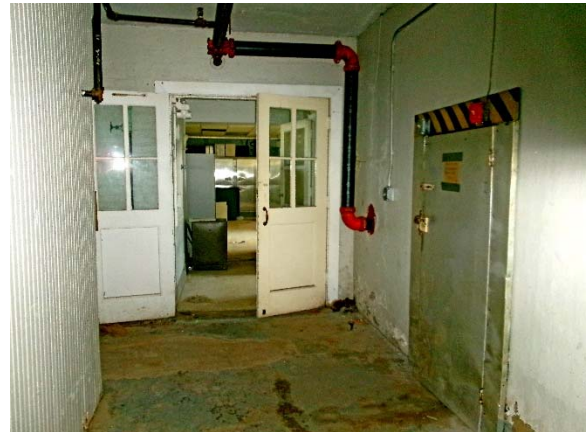
Central hall looking towards kitchen in East Pavilion, with door to mechanical room beneath the Chapel on the right

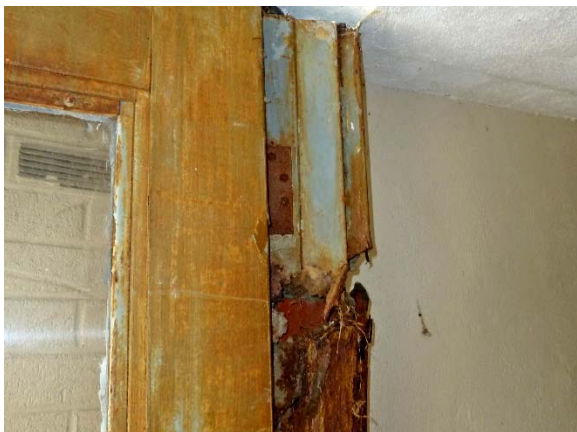
Exterior basement door, at West Elevation: steel frame severely rusted & disconnected with bird nest inside

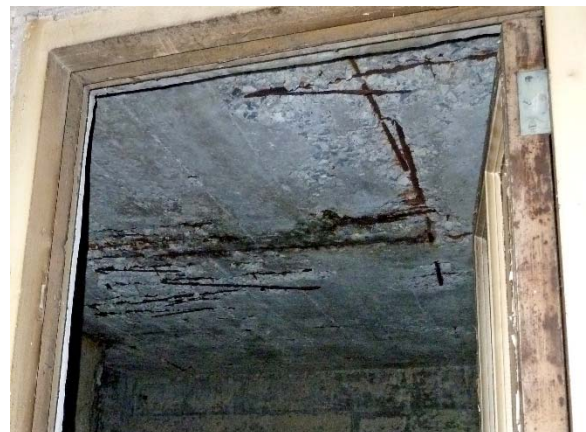
Underside of West first floor entry portico: concrete slab with multiple rebar visible & rusty near the deteriorated surface

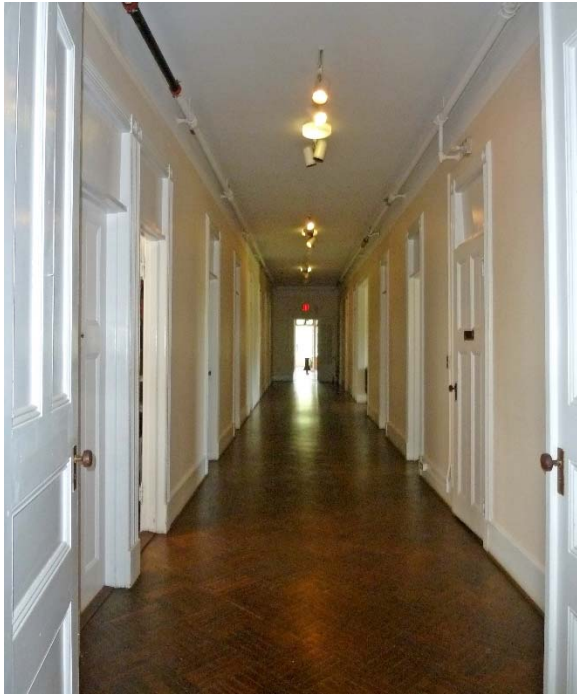
Central hall looking from stair hall outside Chapel westward to main entry vestibule: good condition and currently in use

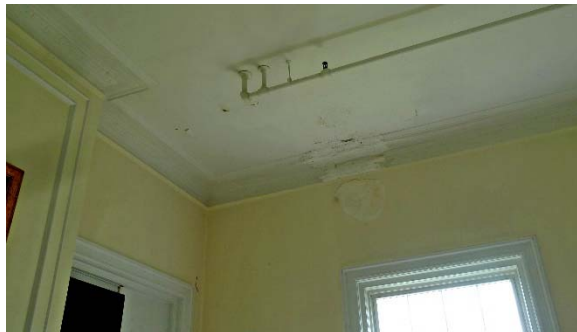
East Pavilion (1924); deteriorated plaster cornice with repair, likely due to water infiltration from roof/gutter; sprinkler pipes

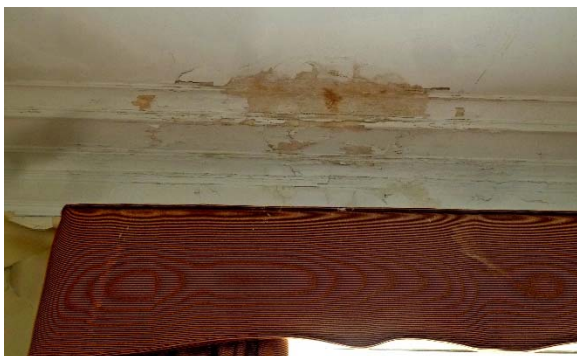
West Addition (1924), north parlor: deteriorated plaster cornice above window valance (similar condition, south parlor)

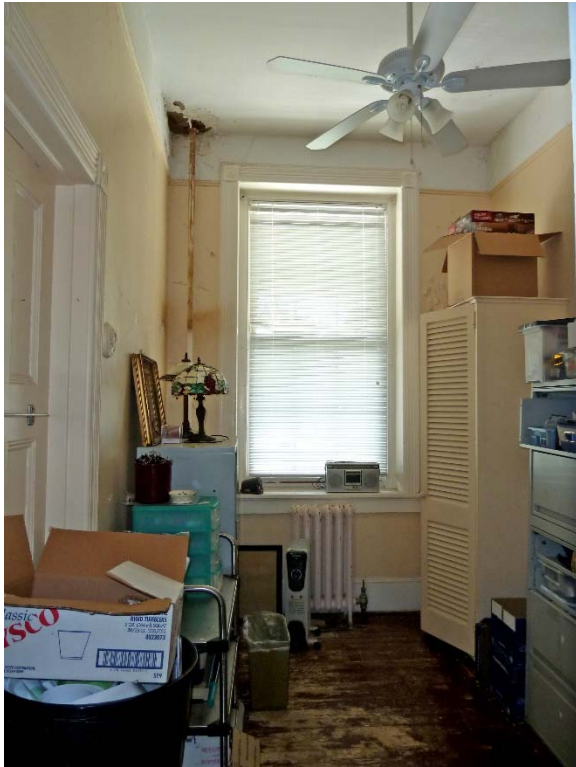
Office: deteriorated dropped ceiling with leaky, rusty pipe; peeling paint on exterior wall

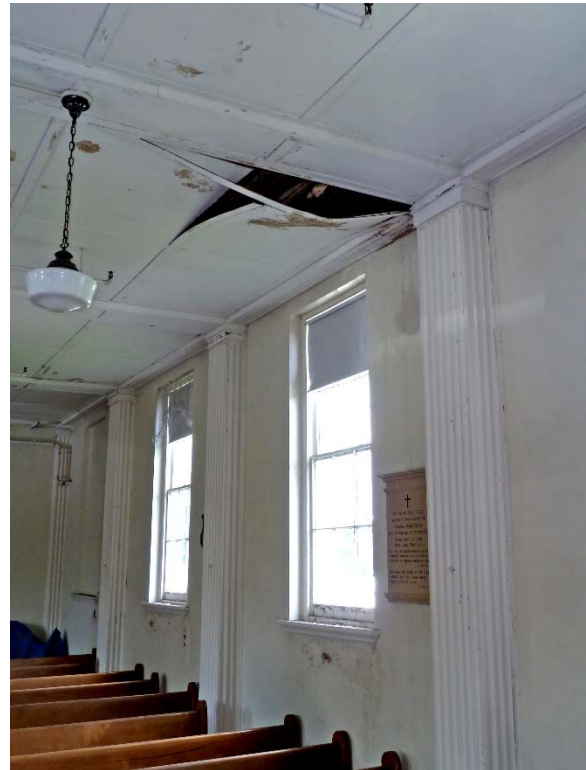
Chapel, north windows: disconnected fiber board applied atop beadboard; deteriorated finishes below window sills

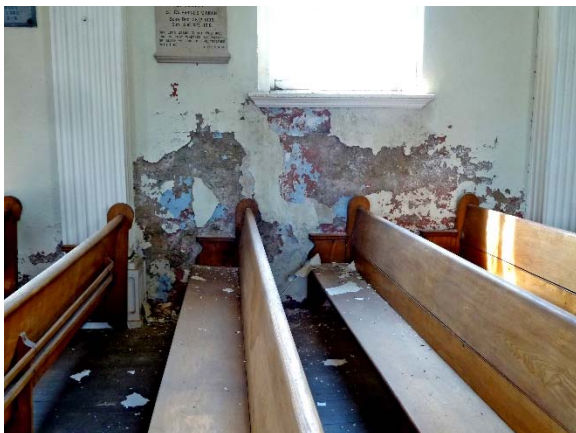
Chapel, south wall: severely deteriorated finishes below window sills, allowing view of previous paint layers & bare concrete

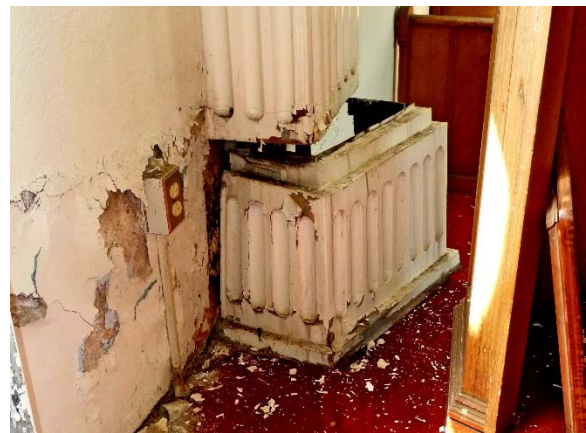
Chapel, south wall by sanctuary: sheet metal pilaster/tie cover disconnected; peeling paint on exterior wall and cover

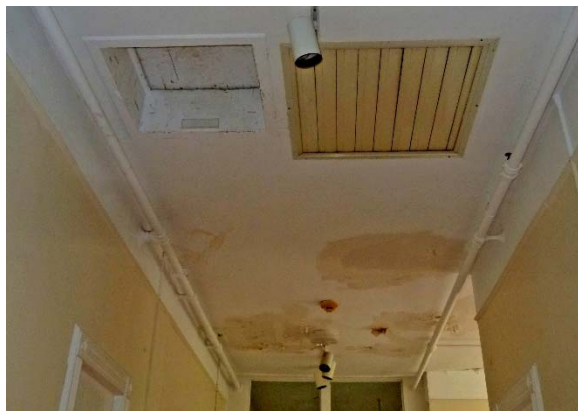
Central Addition (1924), hall near central stair: water-stained ceiling; access panel to attic and louvers to whole-building fan

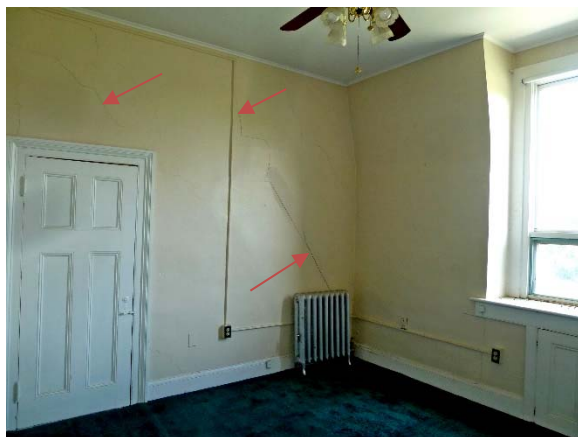
North bedroom near joint with East Portico: severe cracks along entire wall (typical both sides of room)

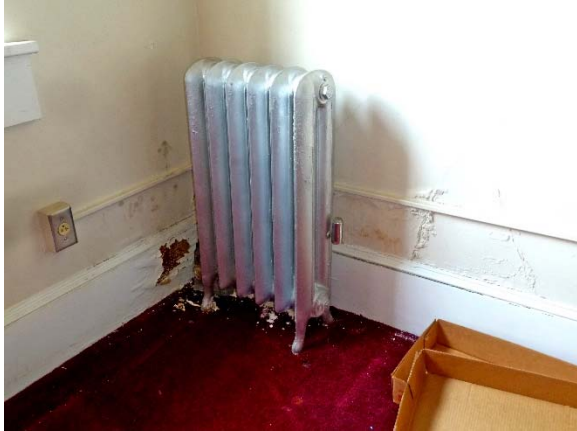
Peeling & bubbling wall and baseboard finishes around steam radiator suggests ineffective or failing controls

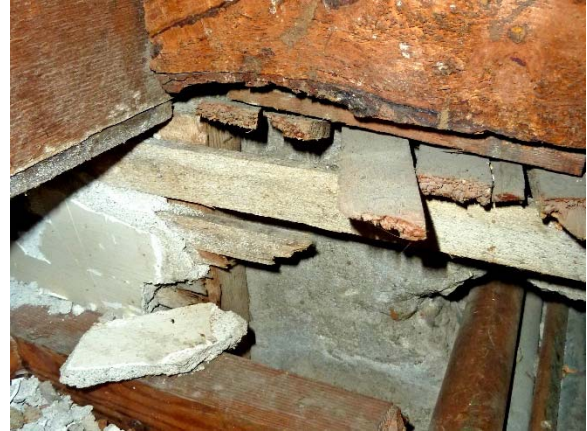
Kitchenette: floor probe exposes plaster walls above a dropped ceiling, and concrete wall penetration

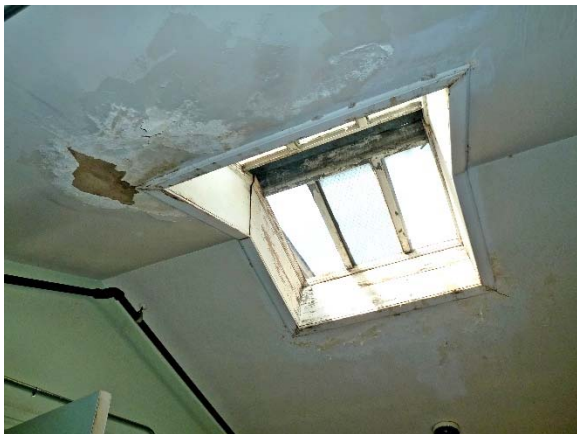
Records room at East Pavilion stair landing: deteriorated ceiling plaster, peeling paint, replacement glazing

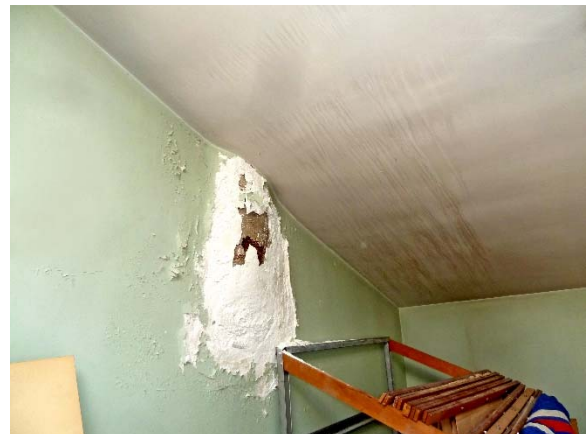
Records room at East Pavilion stair landing: very deteriorated plaster with repair attempt; water-stained ceiling

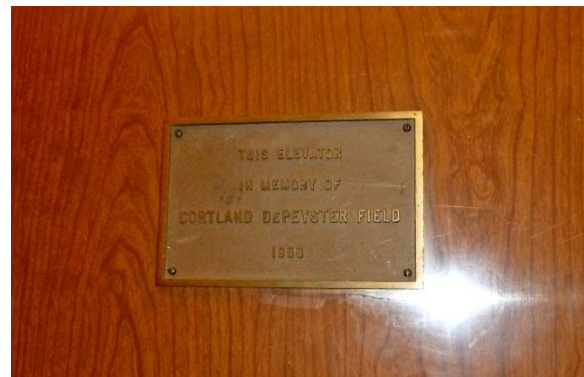
Elevator installed in 1960s, in West Addition (1924): in memory of the founder Cortland dePeyster Field
