**PHASE 1A LITERATURE SEARCH AND SENSITIVITY ASSESSMENT &
PHASE 1B ARCHAEOLOGICAL FIELD RECONNAISSANCE SURVEY
SOUNDVIEW- UNDERHILL FARM PROJECT**

370 UNDERHILL AVENUE
YORKTOWN HEIGHTS, WESTCHESTER COUNTY, NEW YORK

February 2021

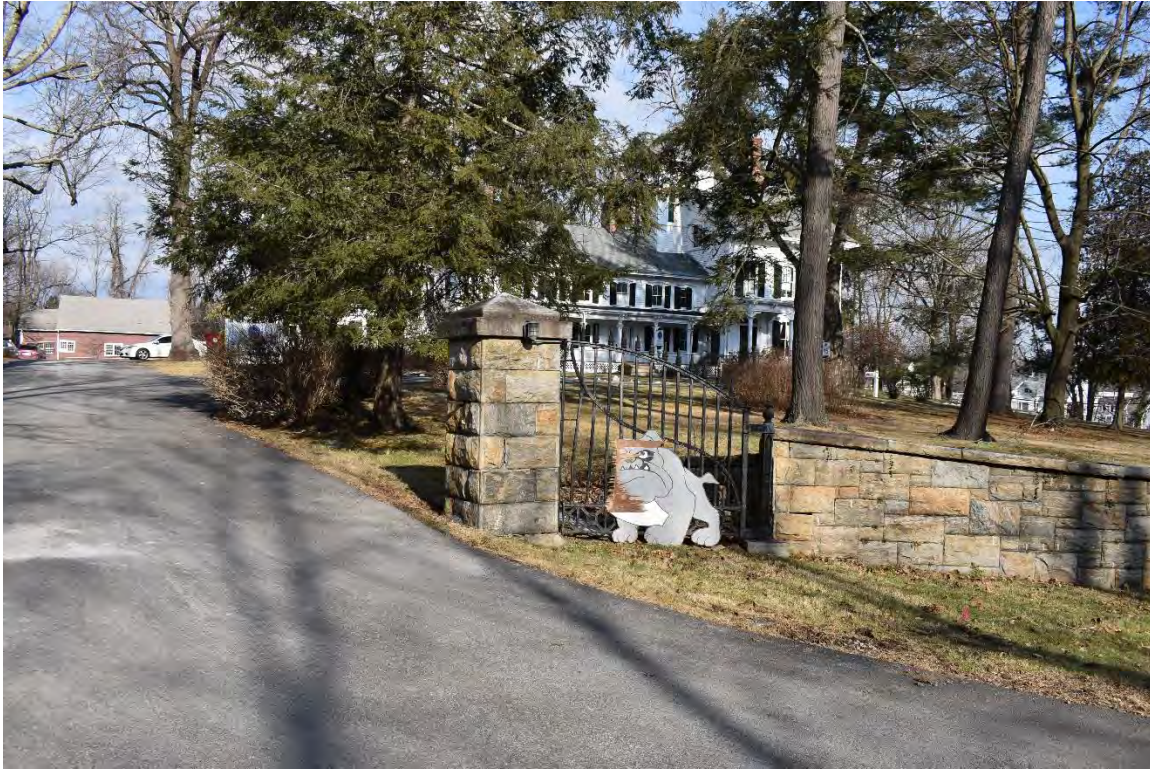
Photo 1: The Project APE is located on the northern side of Underhill Avenue and includes the former Soundview School. View to the north.

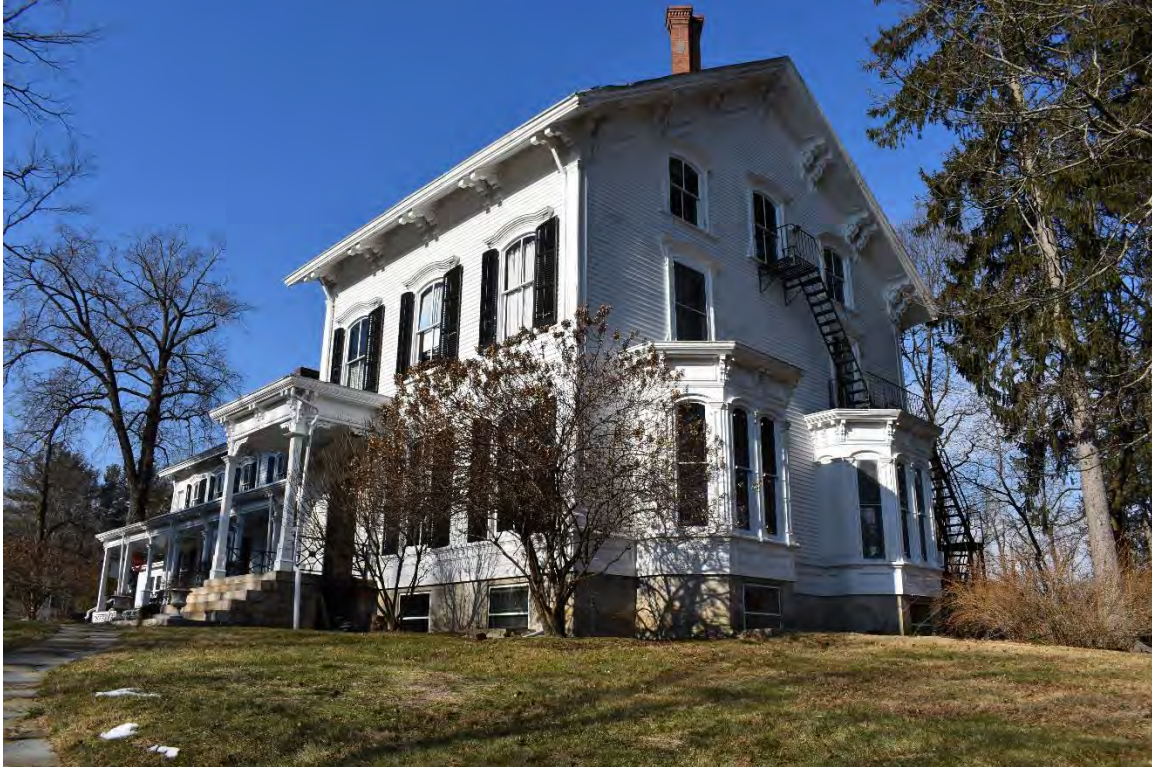
Photo 3: The former school building is located in the southeastern portion of the APE. View to the northwest.

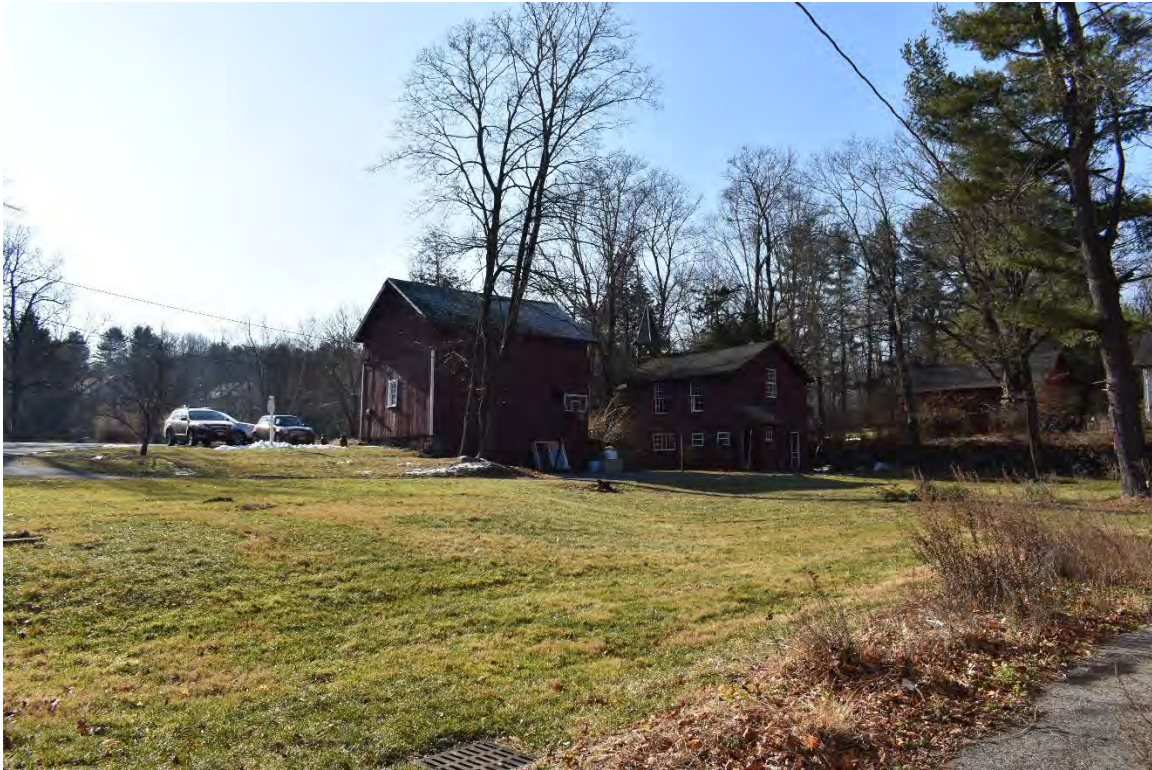
Photo 4: A complex of barns and out buildings are located to the northwest of the former school building. View to the southwest.

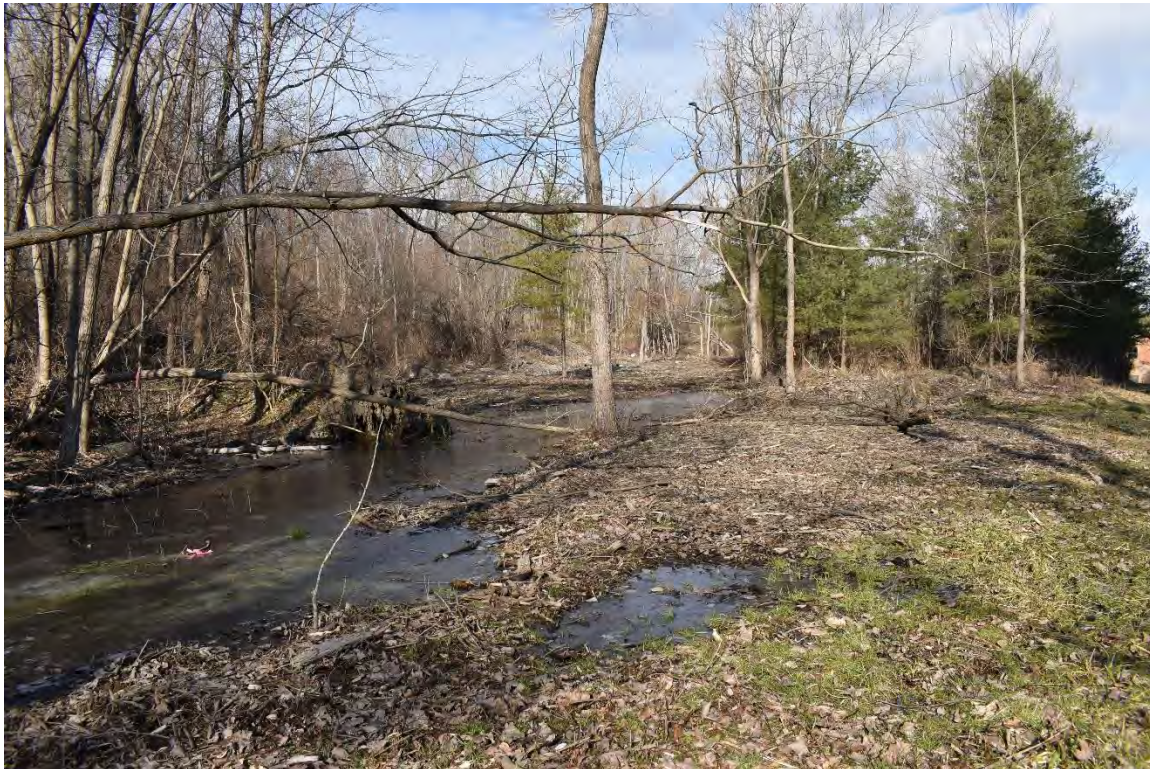
Photo 6: The western portion of the APE is overgrown, and contained areas of standing water. View to the north.

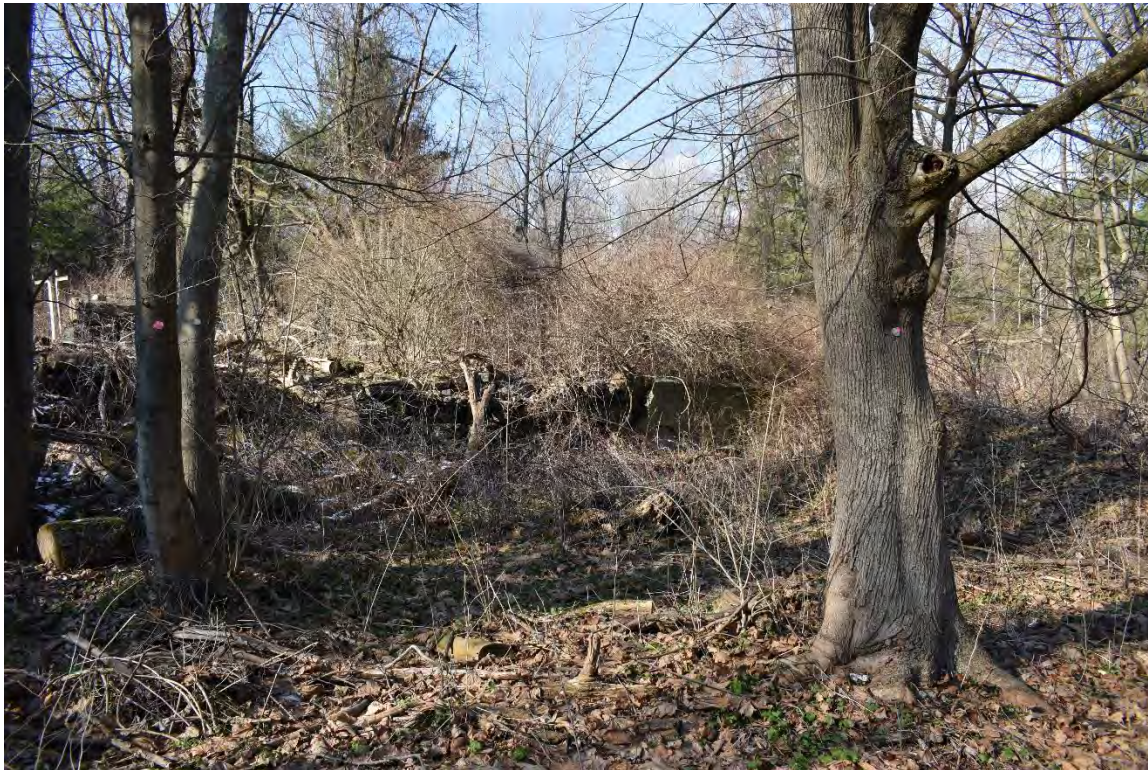
Photo 7: Ruins of a barn or large retaining wall are located in the central portion of the APE. View to the west.

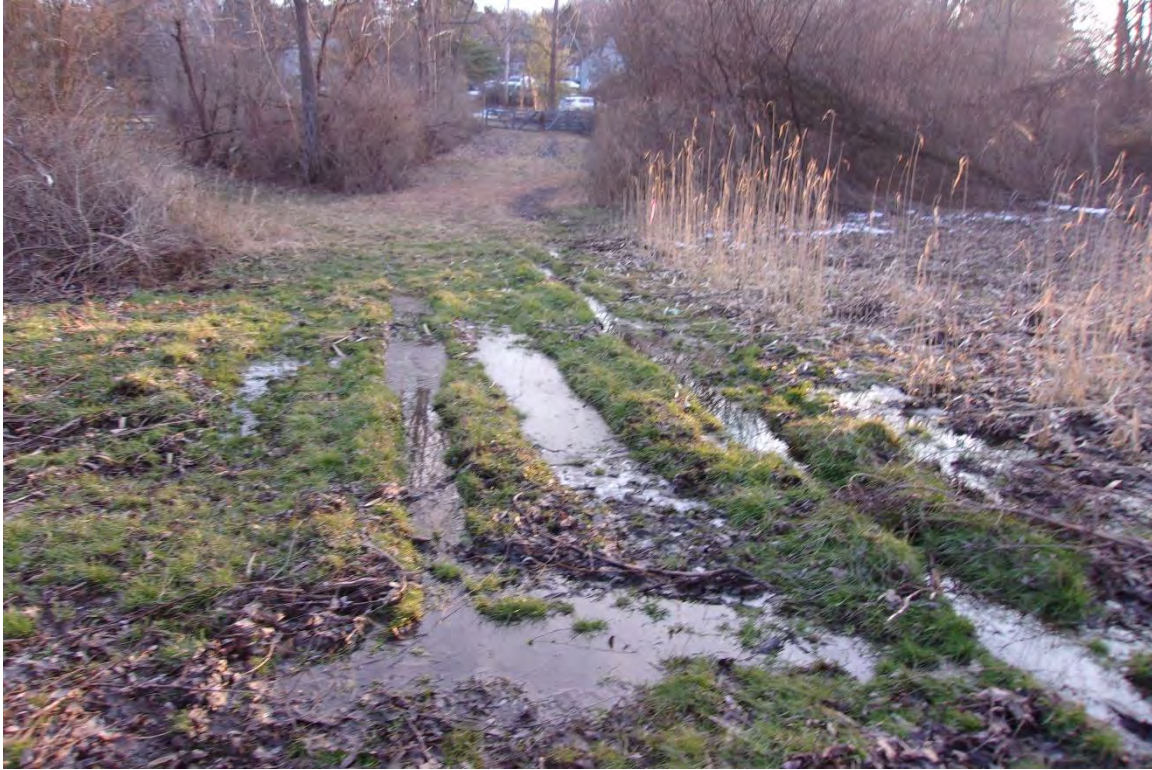
Photo 12: Substantial surface water covered the ground surface in the western part of the Project APE. View to the south.

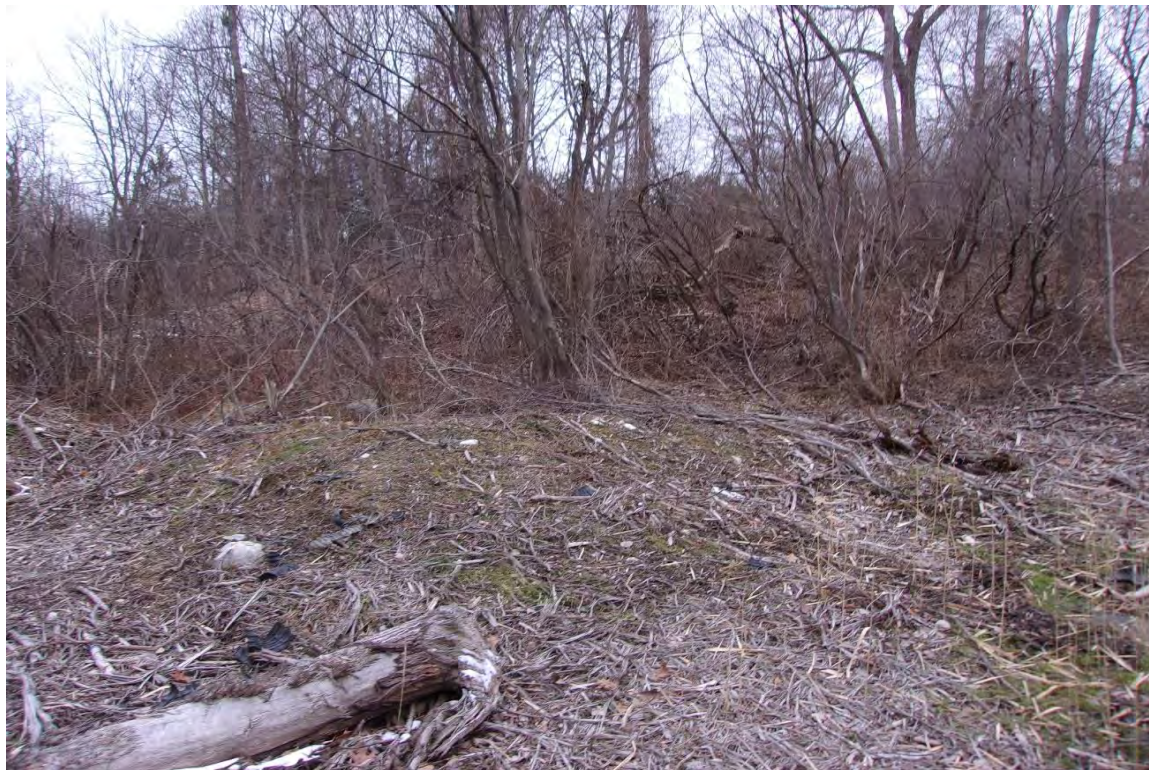
The western portion of the Project APE has been substantially disturbed. The historic aerial images document extensive earth movement in this area, likely associated with the construction of the apartment complex north of the Project APE. At the time of the field investigations, there was substantial amounts of surface water that precluded testing. The northwestern corner of the APE is steeply sloped.

Photo 14: The slopes in the northwestern portion of the APE are comprised of large soil piles. View to the west.

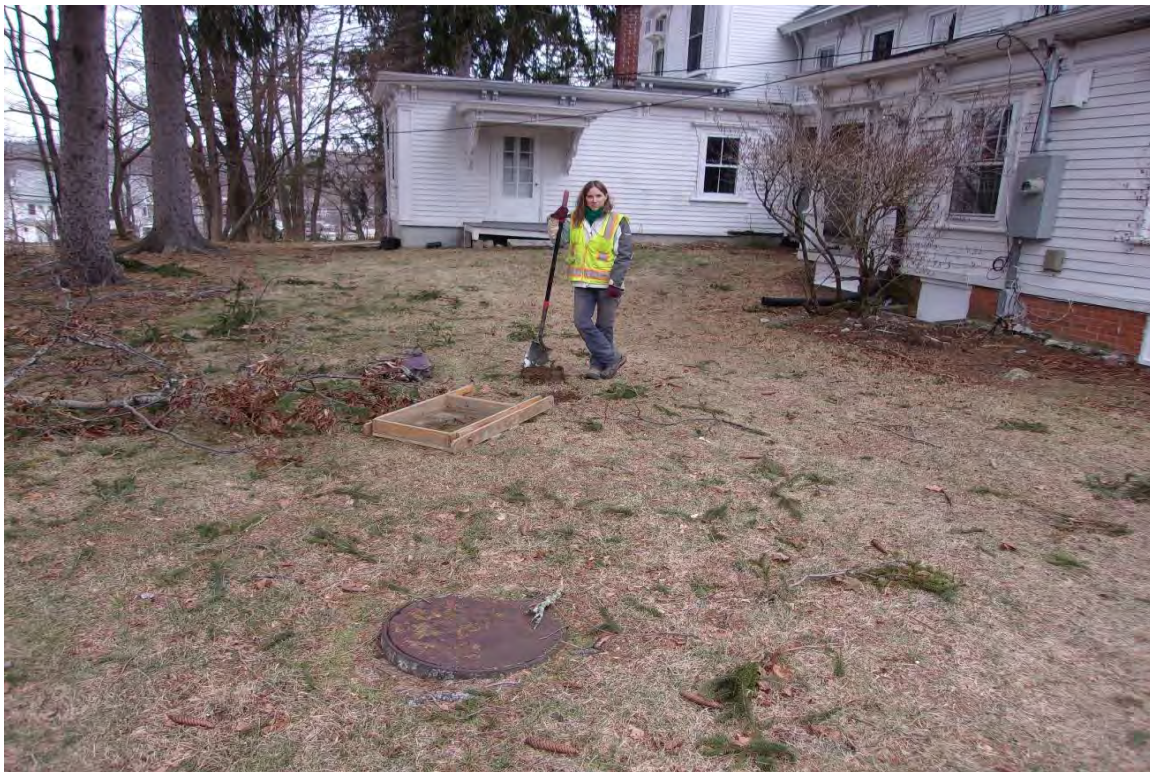
During the walkover inspection the field team noted that the landscape around the house exhibited evidence of modern improvements, including subsurface utilities. The landscape has been modified through the construction and paving of multiple driveways and parking lots. The existing conditions maps, indicated the location of two buildings, Building D and Building F which were demolished sometime in the past decade. Building E was rehabilitated, and converted into a science building in 2012.

Photo 16: The yard on the northern side of the house featured subsurface infrastructure. View to the east of ST 82.

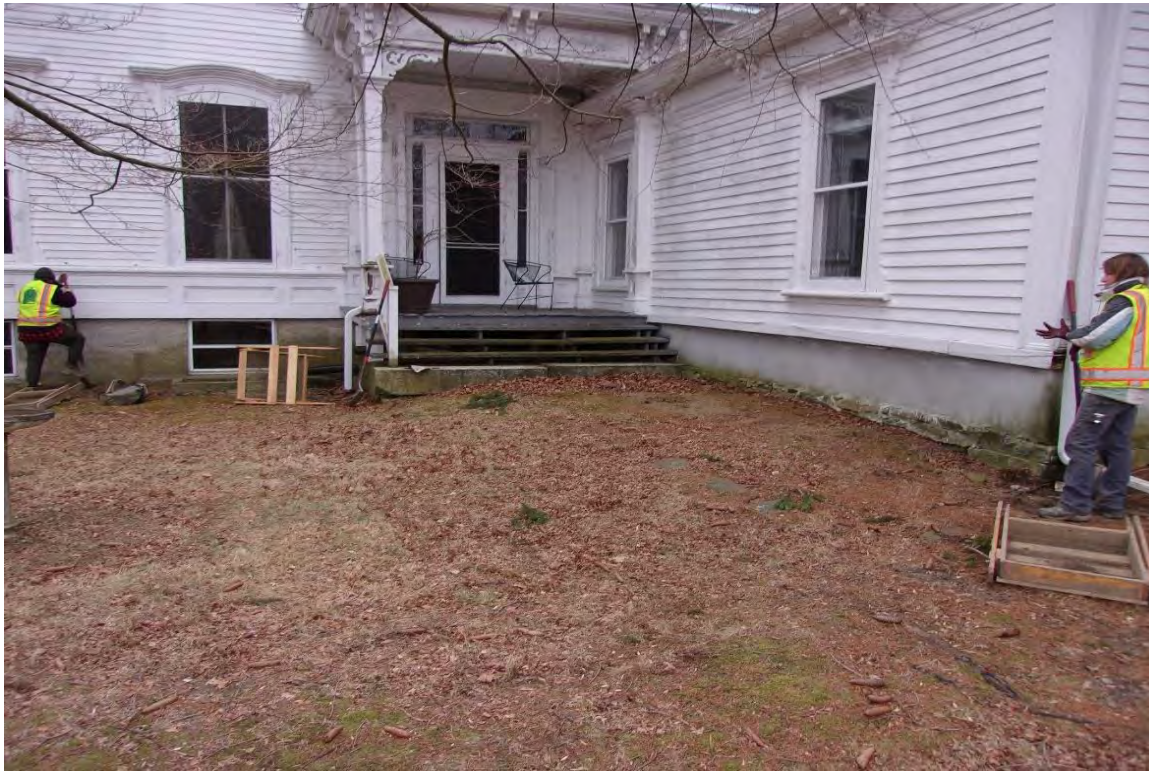
Photo 17: The perimeter of Building A was tested at 10' (3.04 m) intervals. View to the south.

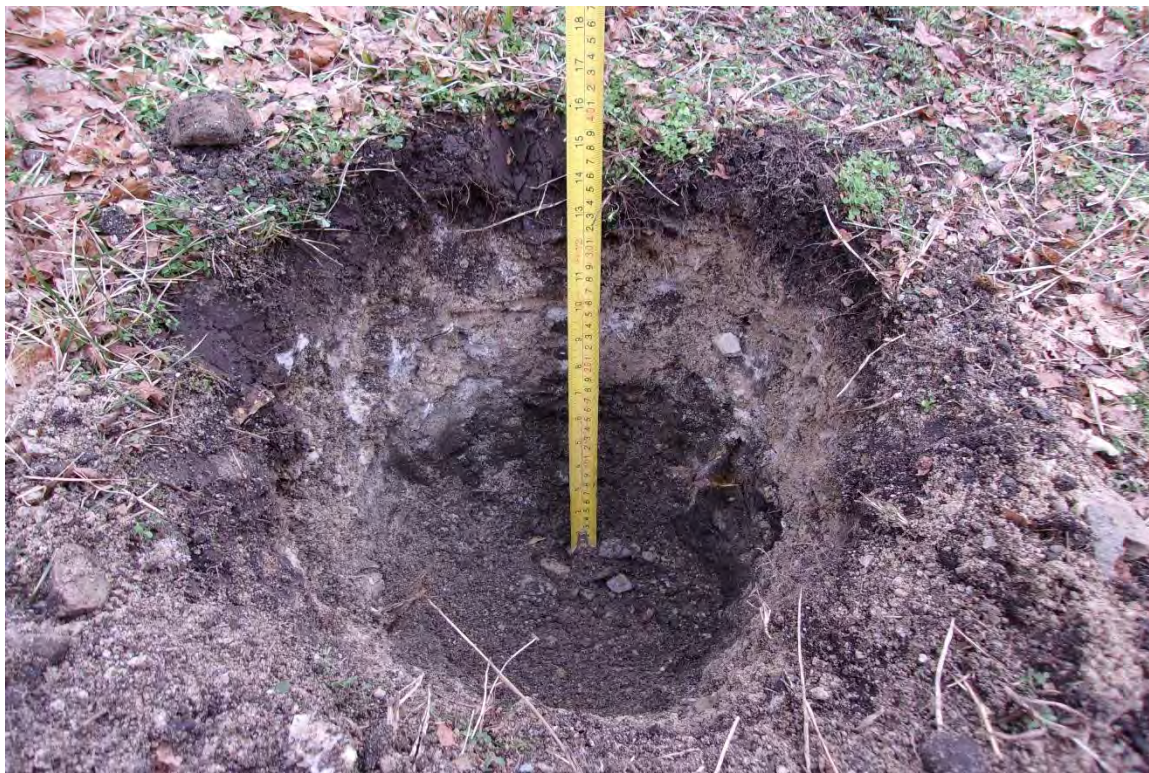
Photo 18: The soils within the Project APE showed extensive soil displacement. View of ST 7.
